# PHASE I ENVIRONMENTAL SITE ASSESSMENT

Northstar Variety  
204 New Sweden Road  
New Sweden, Maine

Prepared for:  
Maine Department of Environmental Protection  
17 State House Station  
Augusta, Maine 04333

**June 25, 2026**

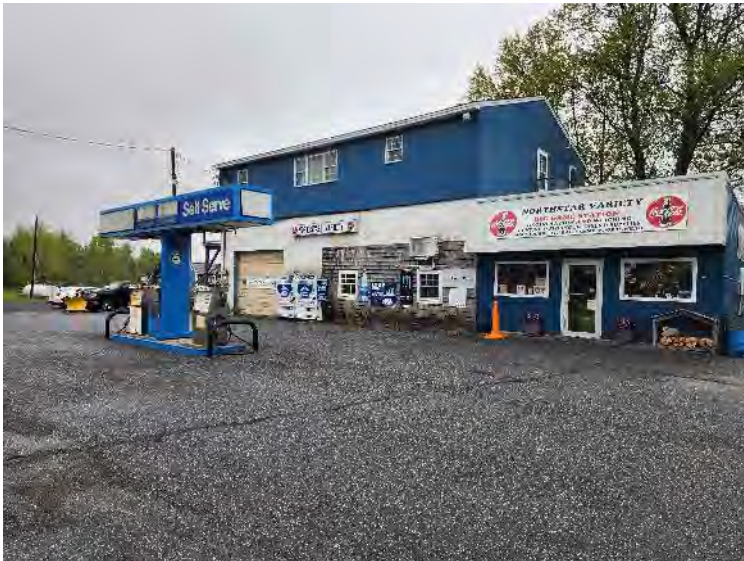
Commercial building and dispensers looking southwest

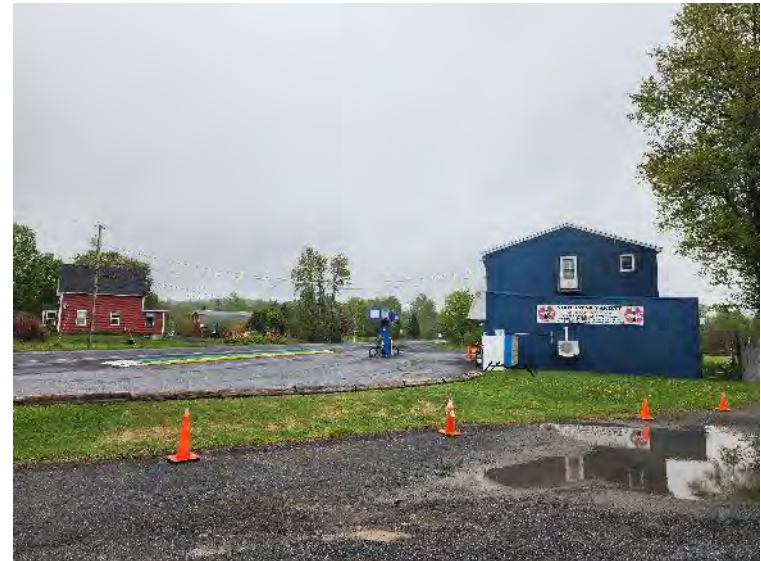
View of subject property looking southeast

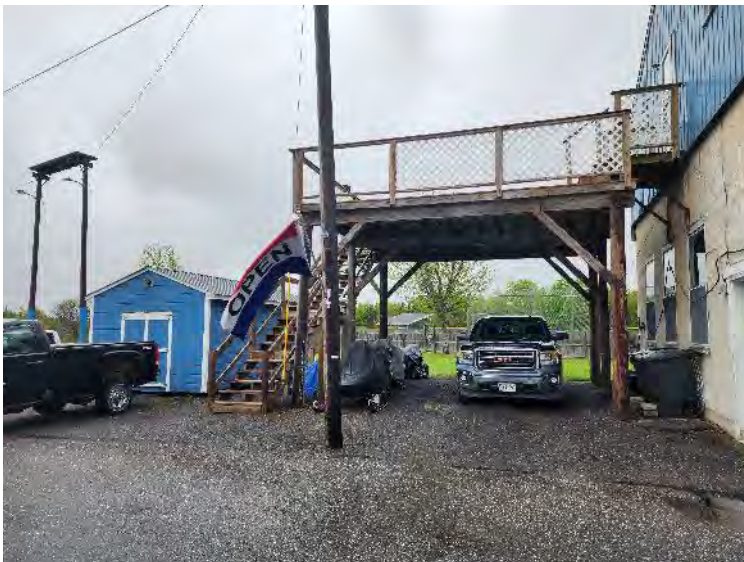
Shed, deck, trash bins, fill and vent piping south of commercial building

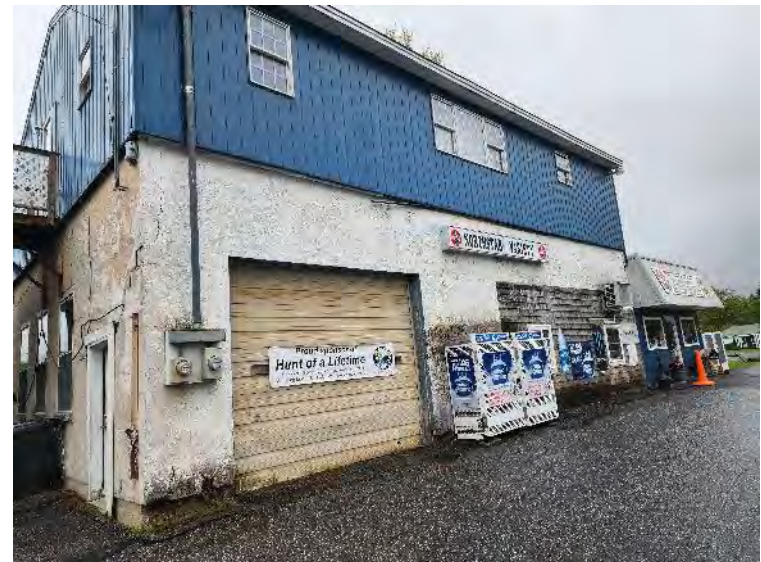
East side of commercial building looking northwest, garage

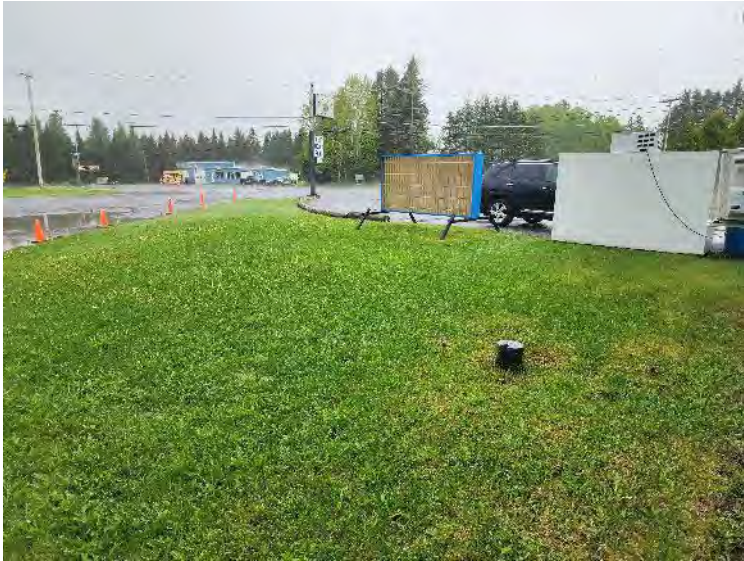
On-site private water supply well north of commercial building

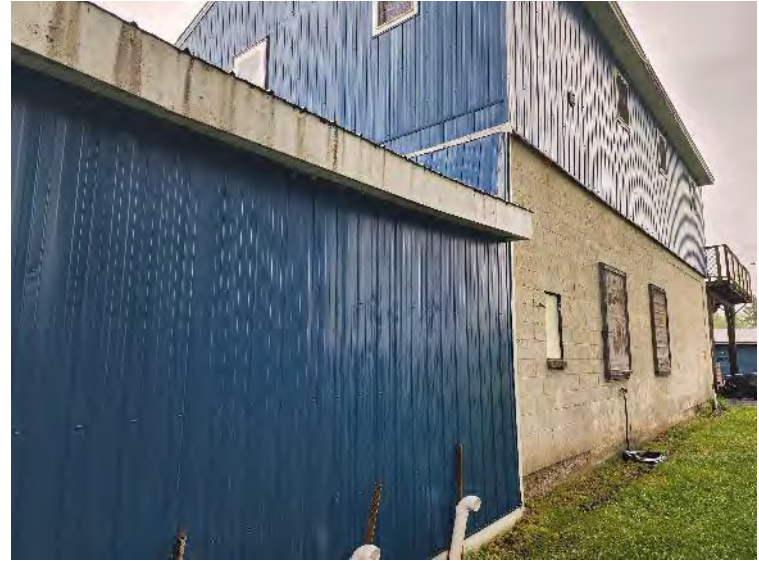
PVC vent pipes, west side of commercial building looking southeast

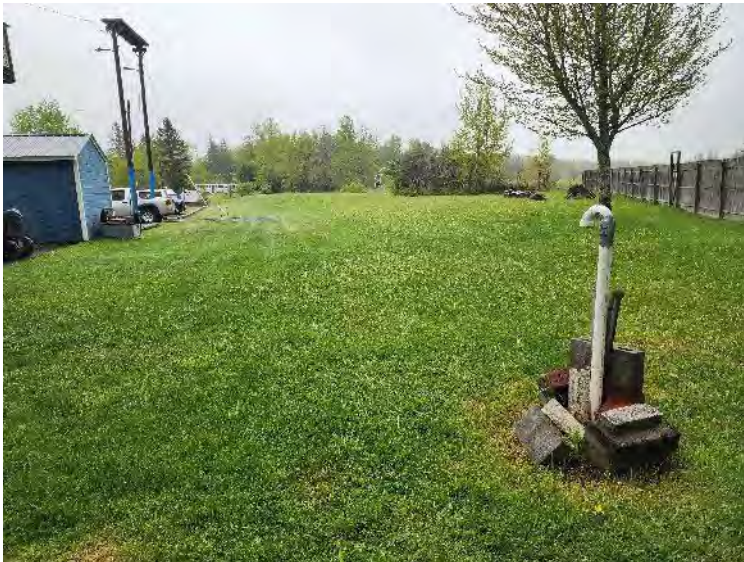
Vent pipe, holding tank west of commercial building

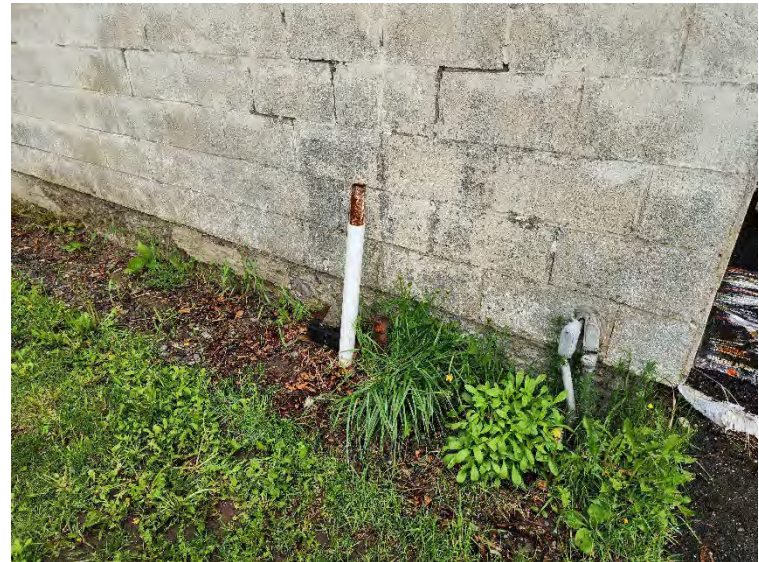
Two buried 1.5-inch steel pipes, possible UST?

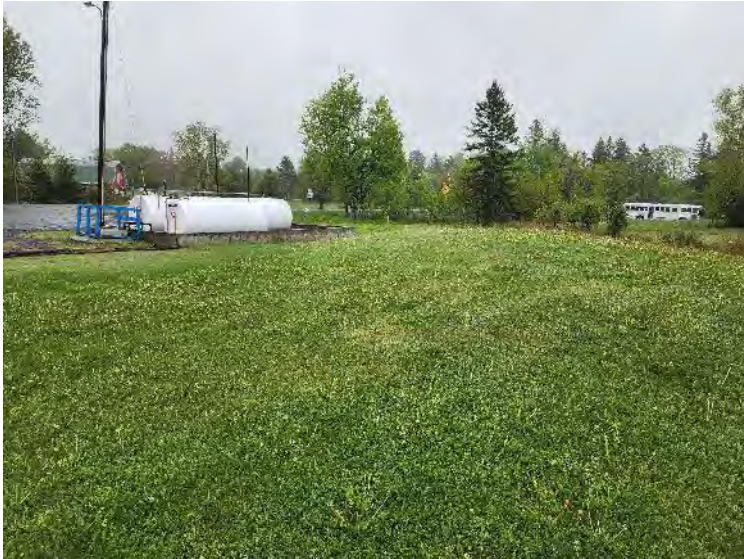
South yard looking southeast, leach field, gasoline ASTs

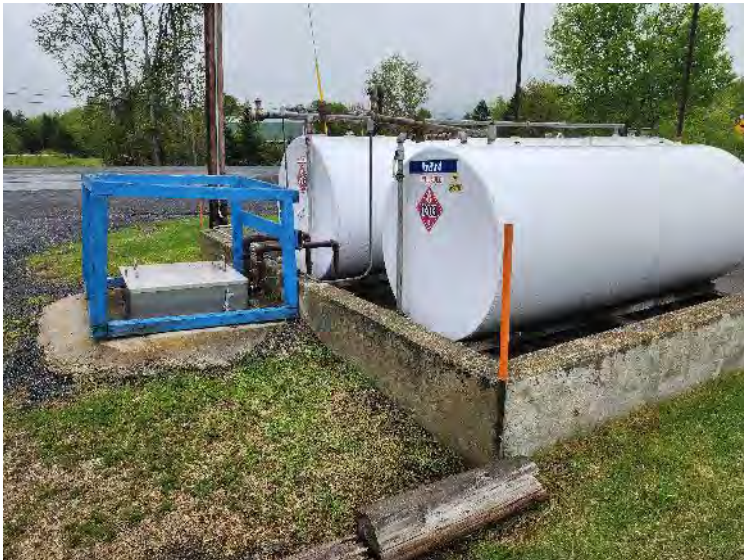
Gasoline ASTs, transition sump south in south yard

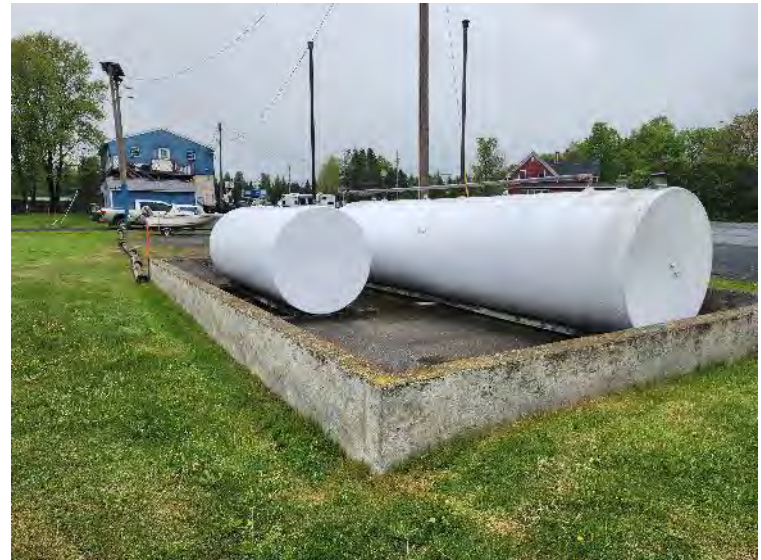
Gasoline ASTs, concrete dike in south yard

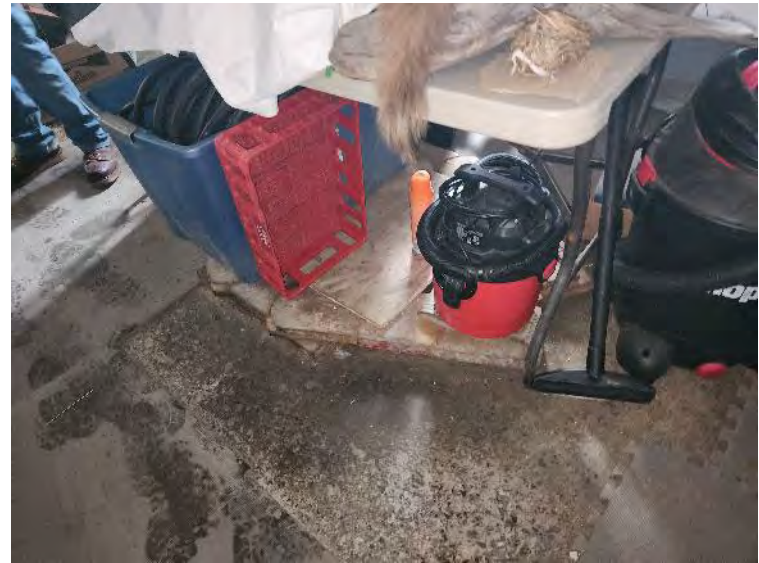
In-ground hydraulic lift, garage bay

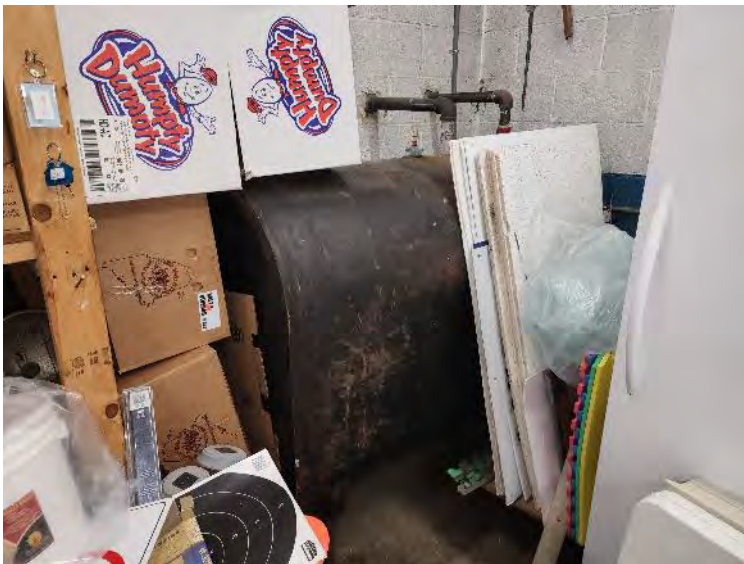
275-gallon fuel oil tank in southwest corner of garage

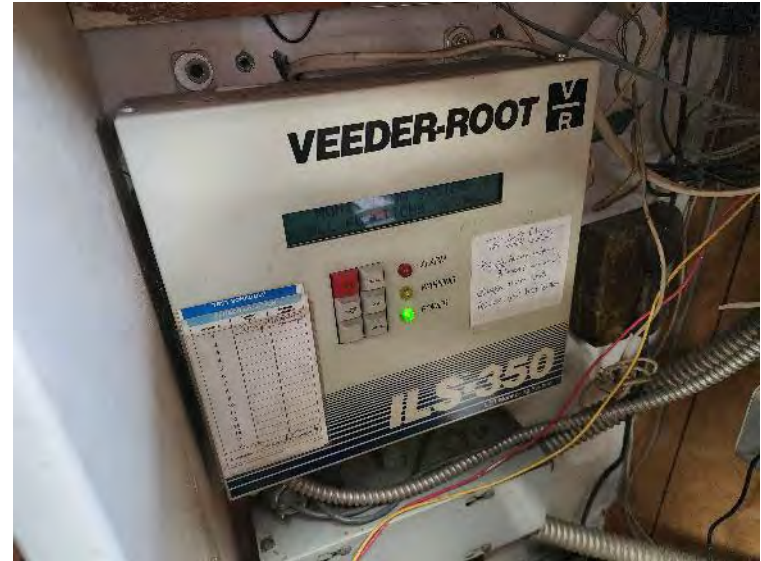
Transition sump leak detection monitoring console
