**Figure 4-14**  
**Flow Field 3 Bedrock Groundwater Composite PFAS Analytical Results**

Remedial Investigation Site Characterization Summary Report  
Former Loring Air Force Base, Limestone, ME

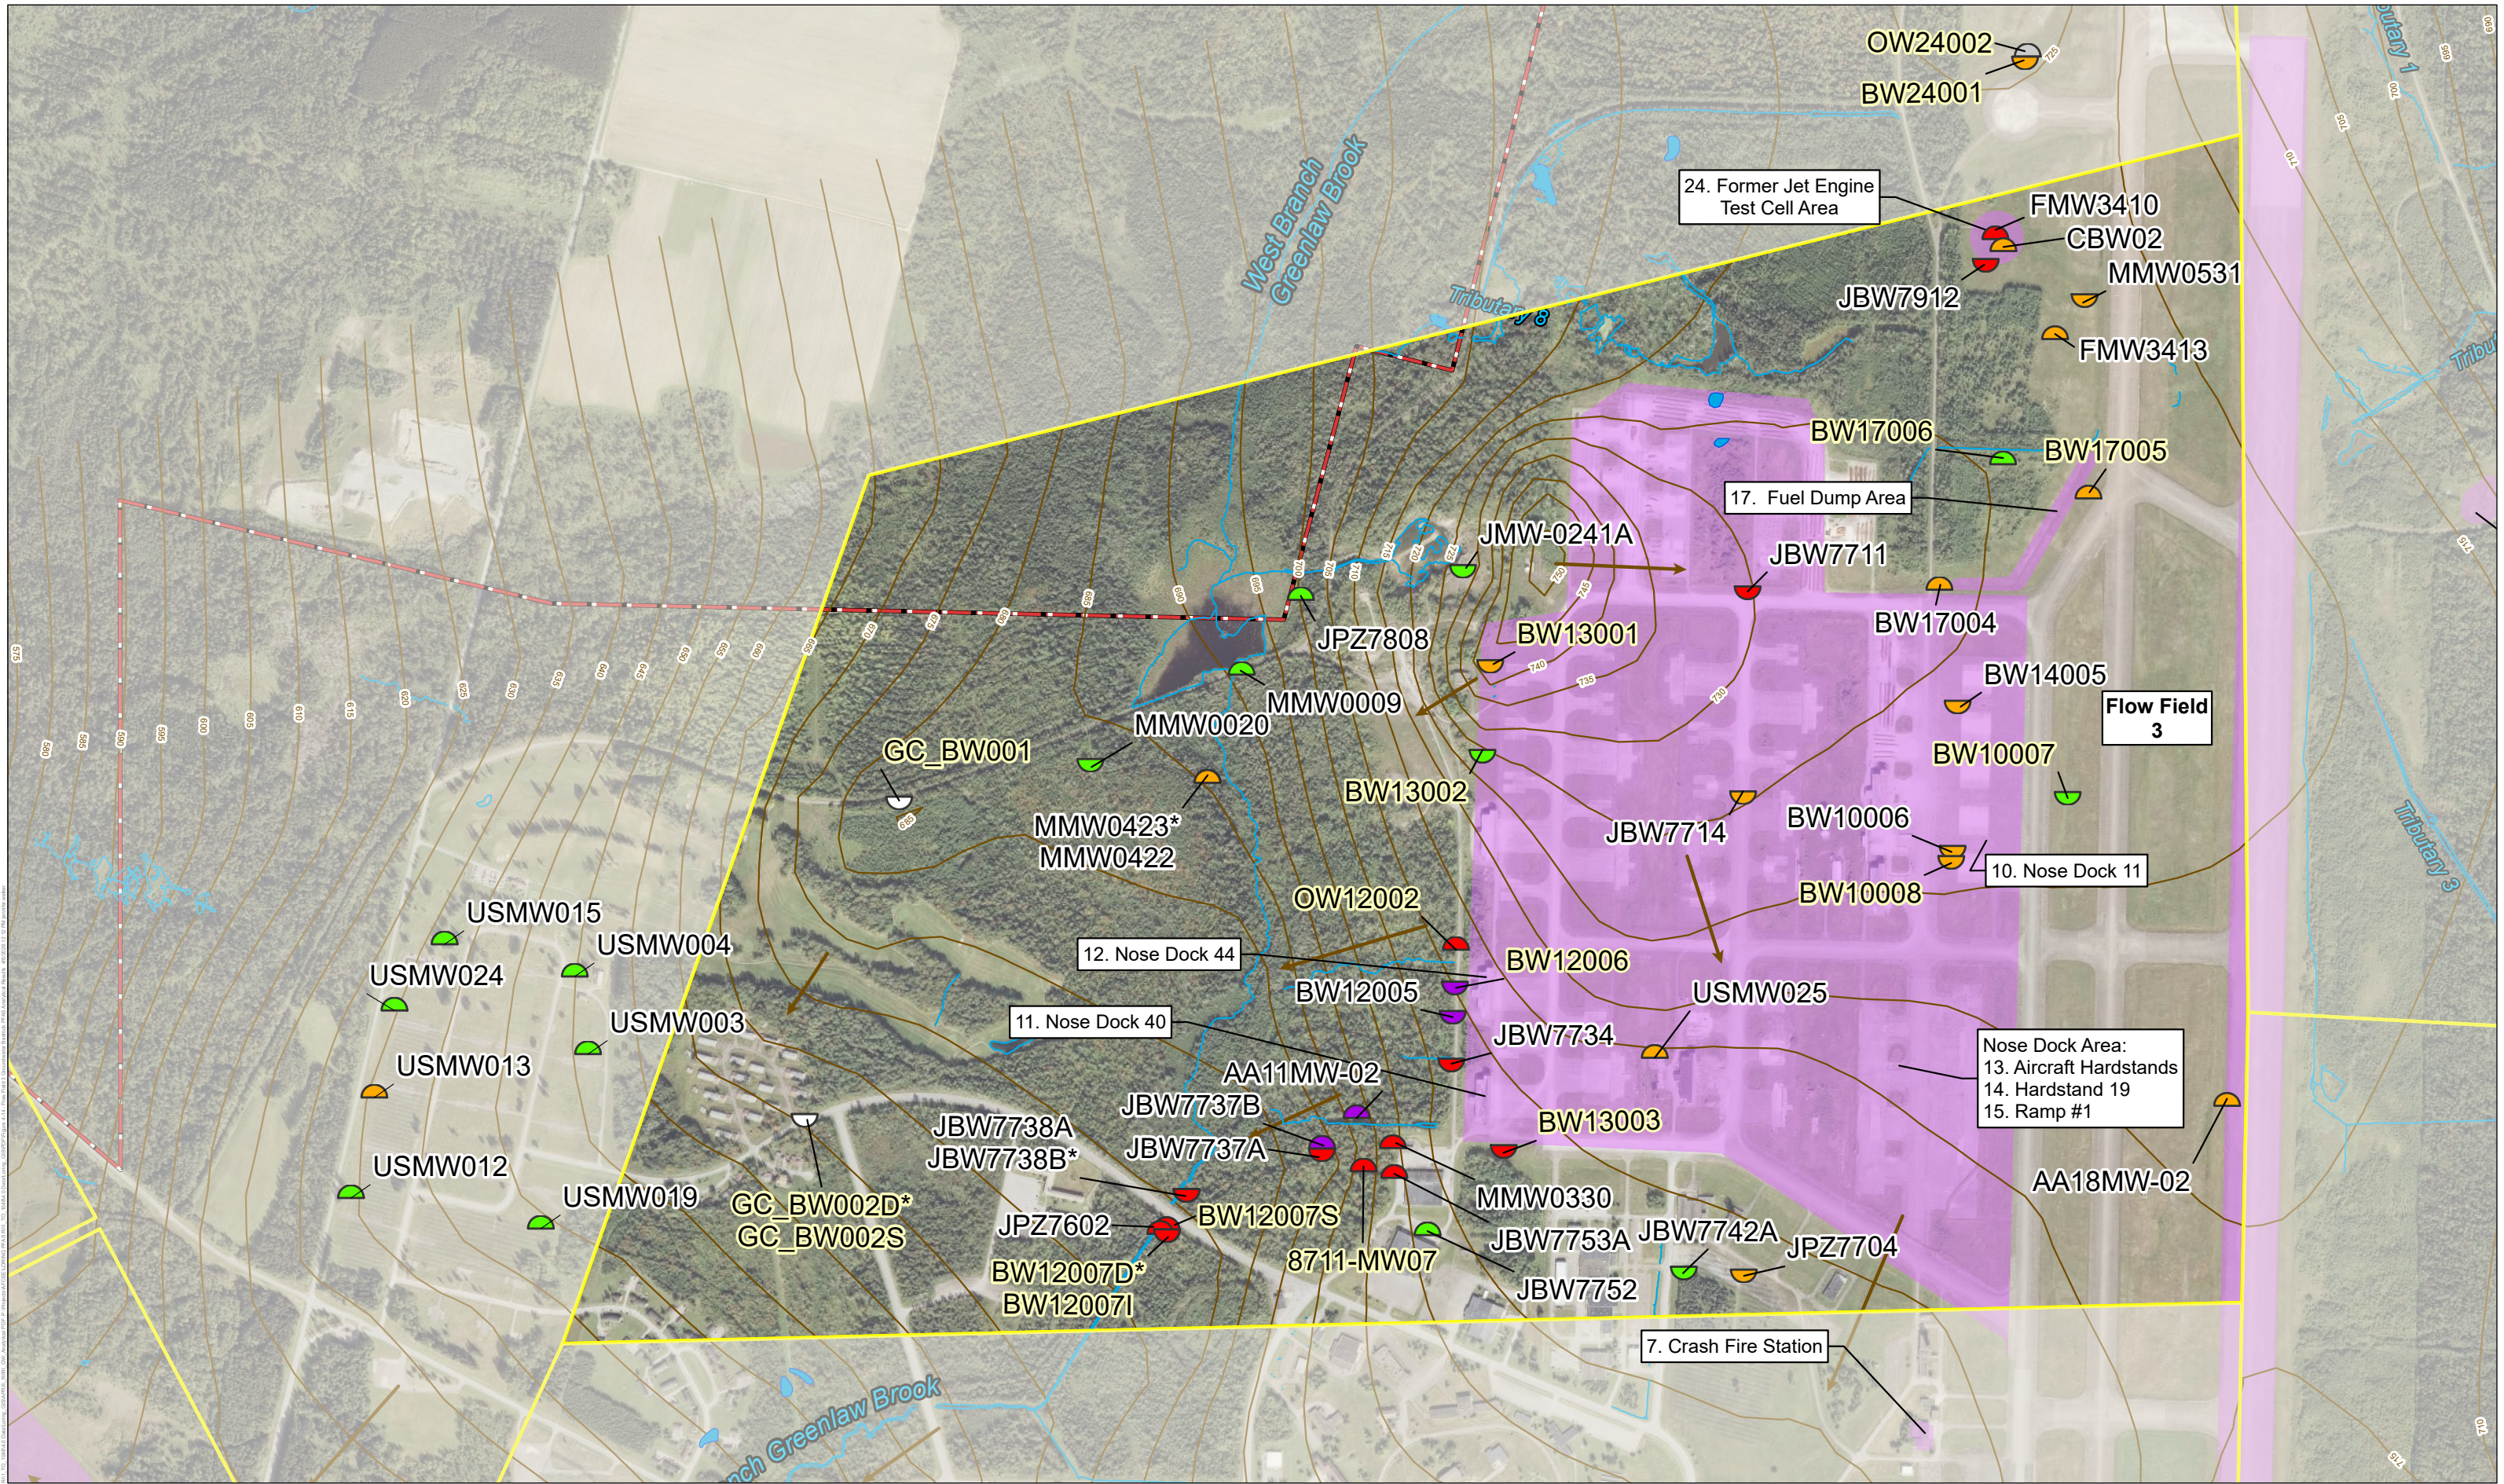
- Bedrock wells depicted as half circles to indicate depth.
- Shallow Bedrock Well
- Deep Bedrock Well

- White Border - Existing Monitoring Wells
- Yellow Border - Monitoring wells installed during the Remedial Investigation
- \*Co-located wells: Higher sample result depicted

Figure depicts most recent sampling result for each location.  
\*See Table 1-3 for more information about screening levels
