**Figure 4-15**  
**Flow Field 4 Overburden Groundwater Composite PFAS Analytical Results**

Remedial Investigation Site Characterization Summary Report  
Former Loring Air Force Base, Limestone, ME

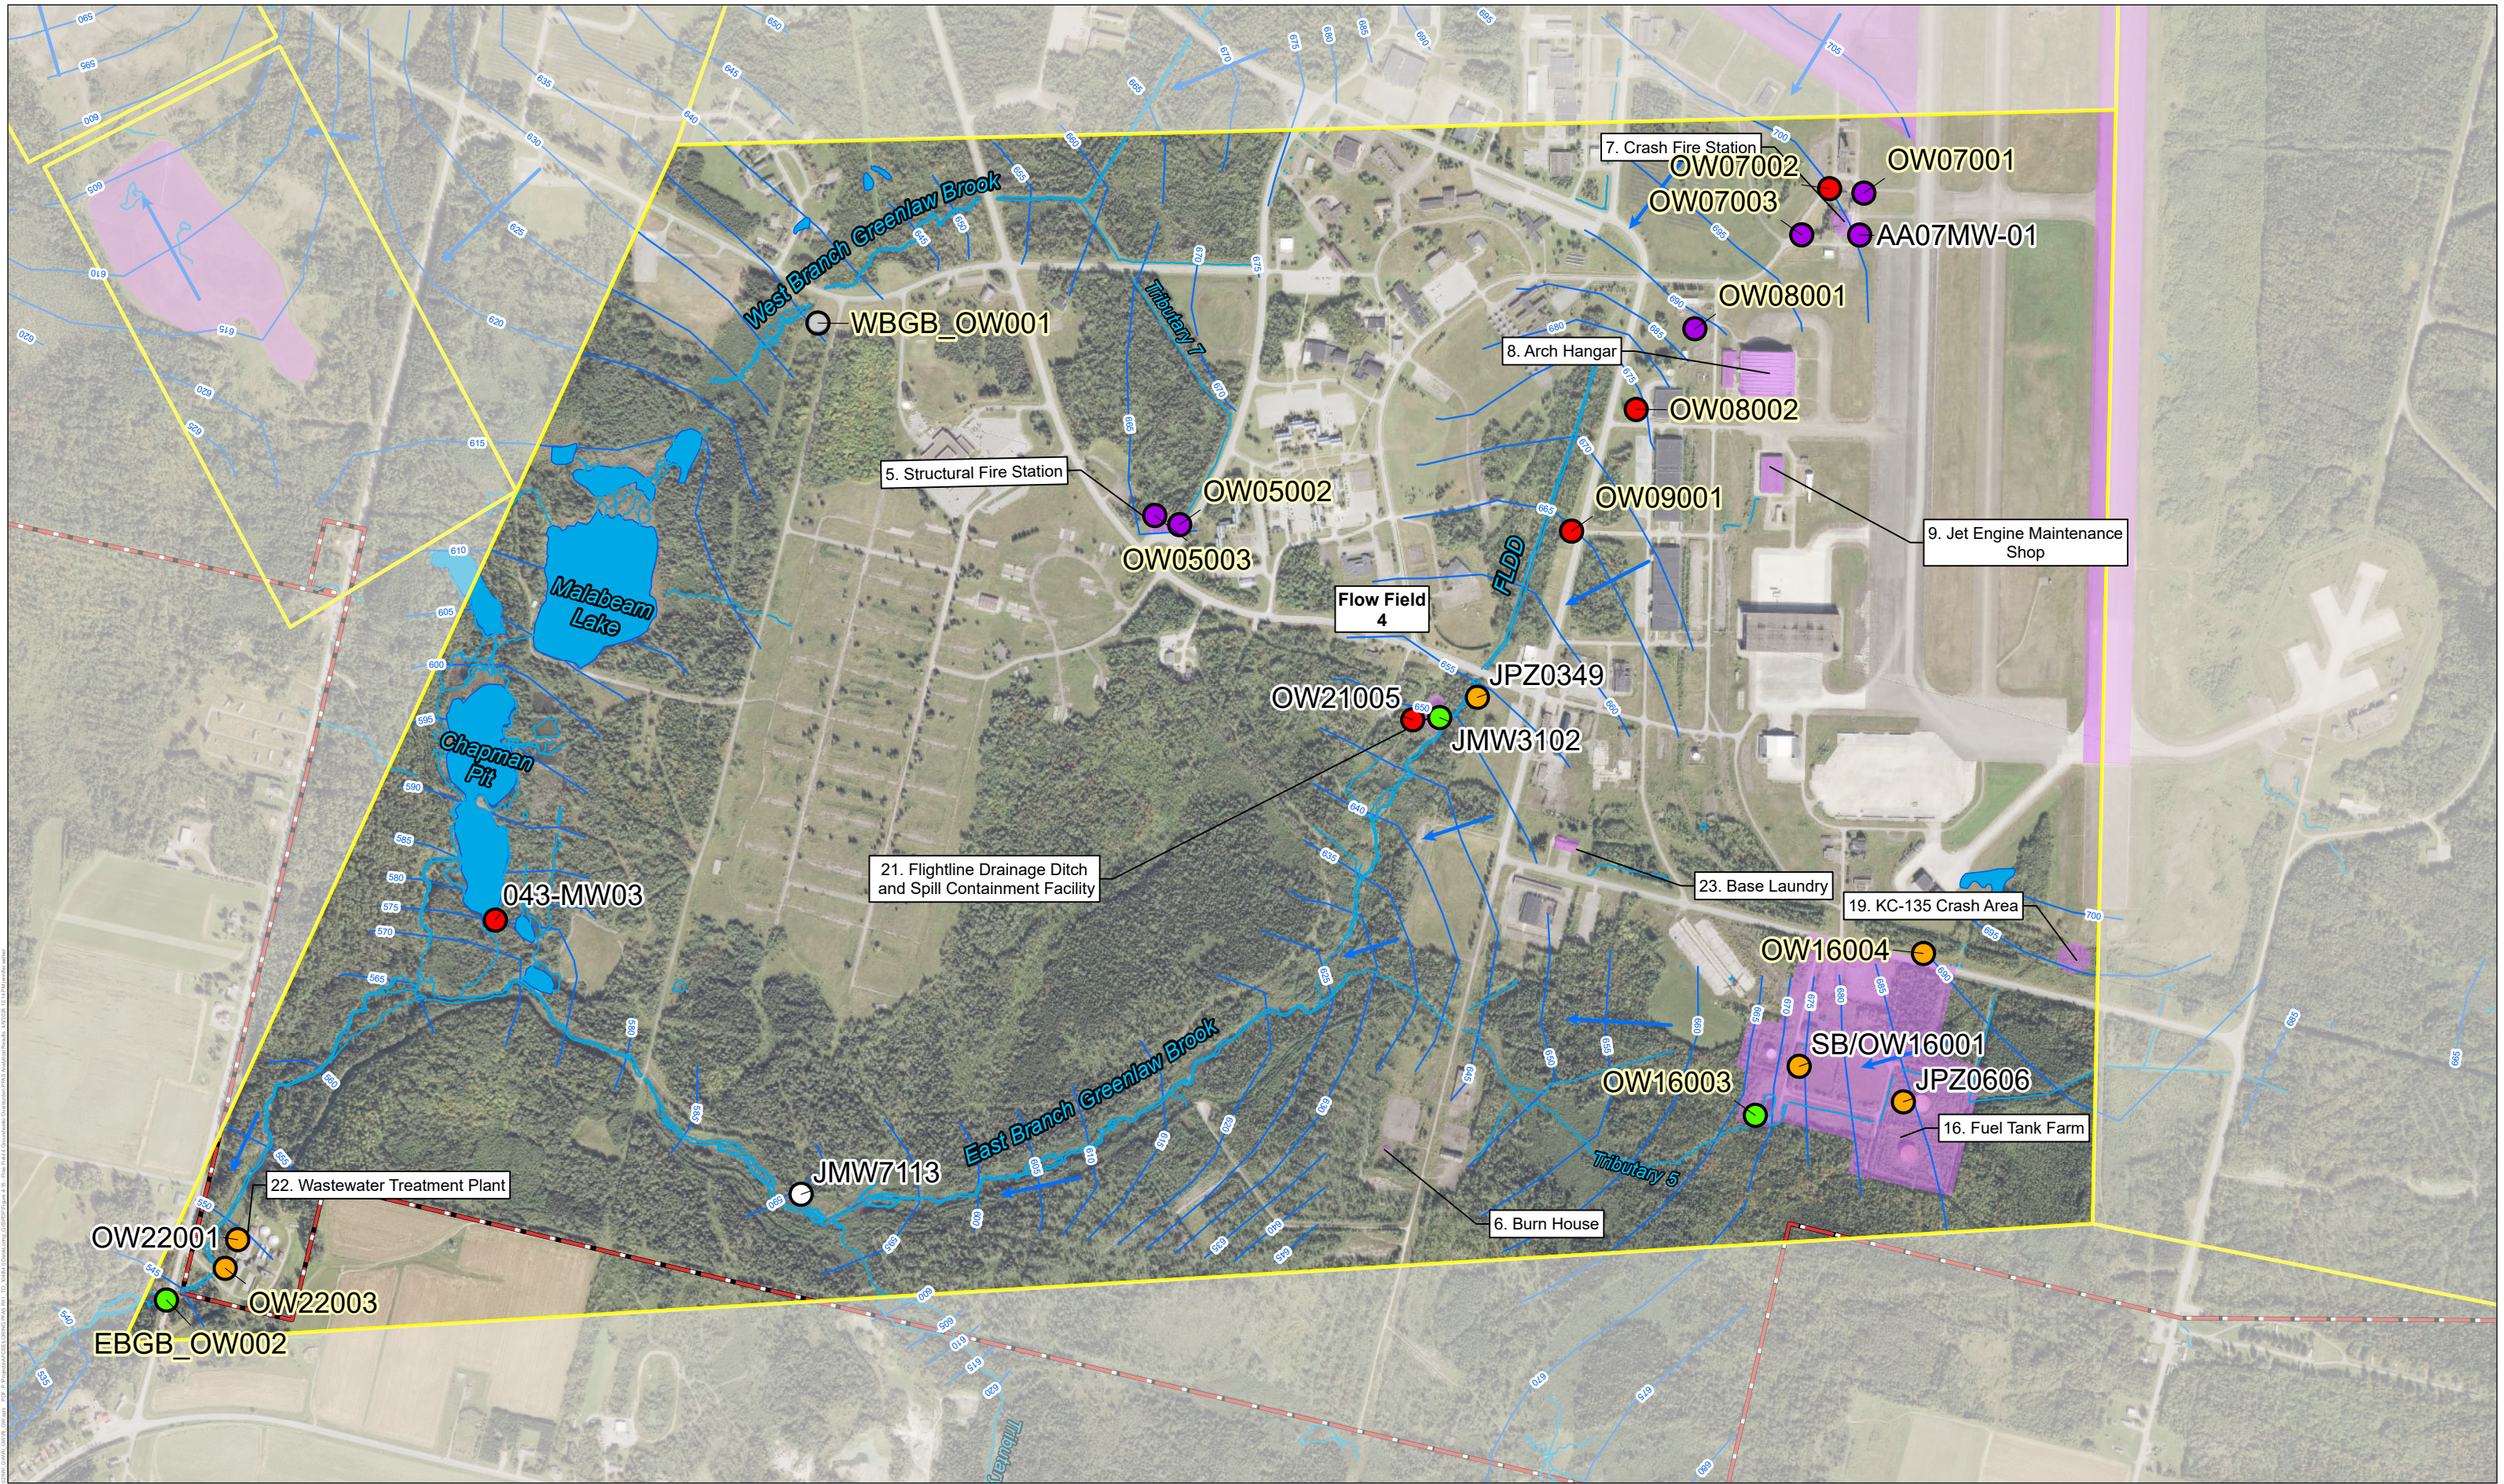
Figure depicts most recent sampling result for each location.  
\*\*See Table 1-3 for more information about screening levels
