**Figure 4-19**

**Flow Field 6 Overburden Groundwater Composite PFAS Analytical Results**

Remedial Investigation Site Characterization Summary Report

Former Loring Air Force Base, Limestone, ME

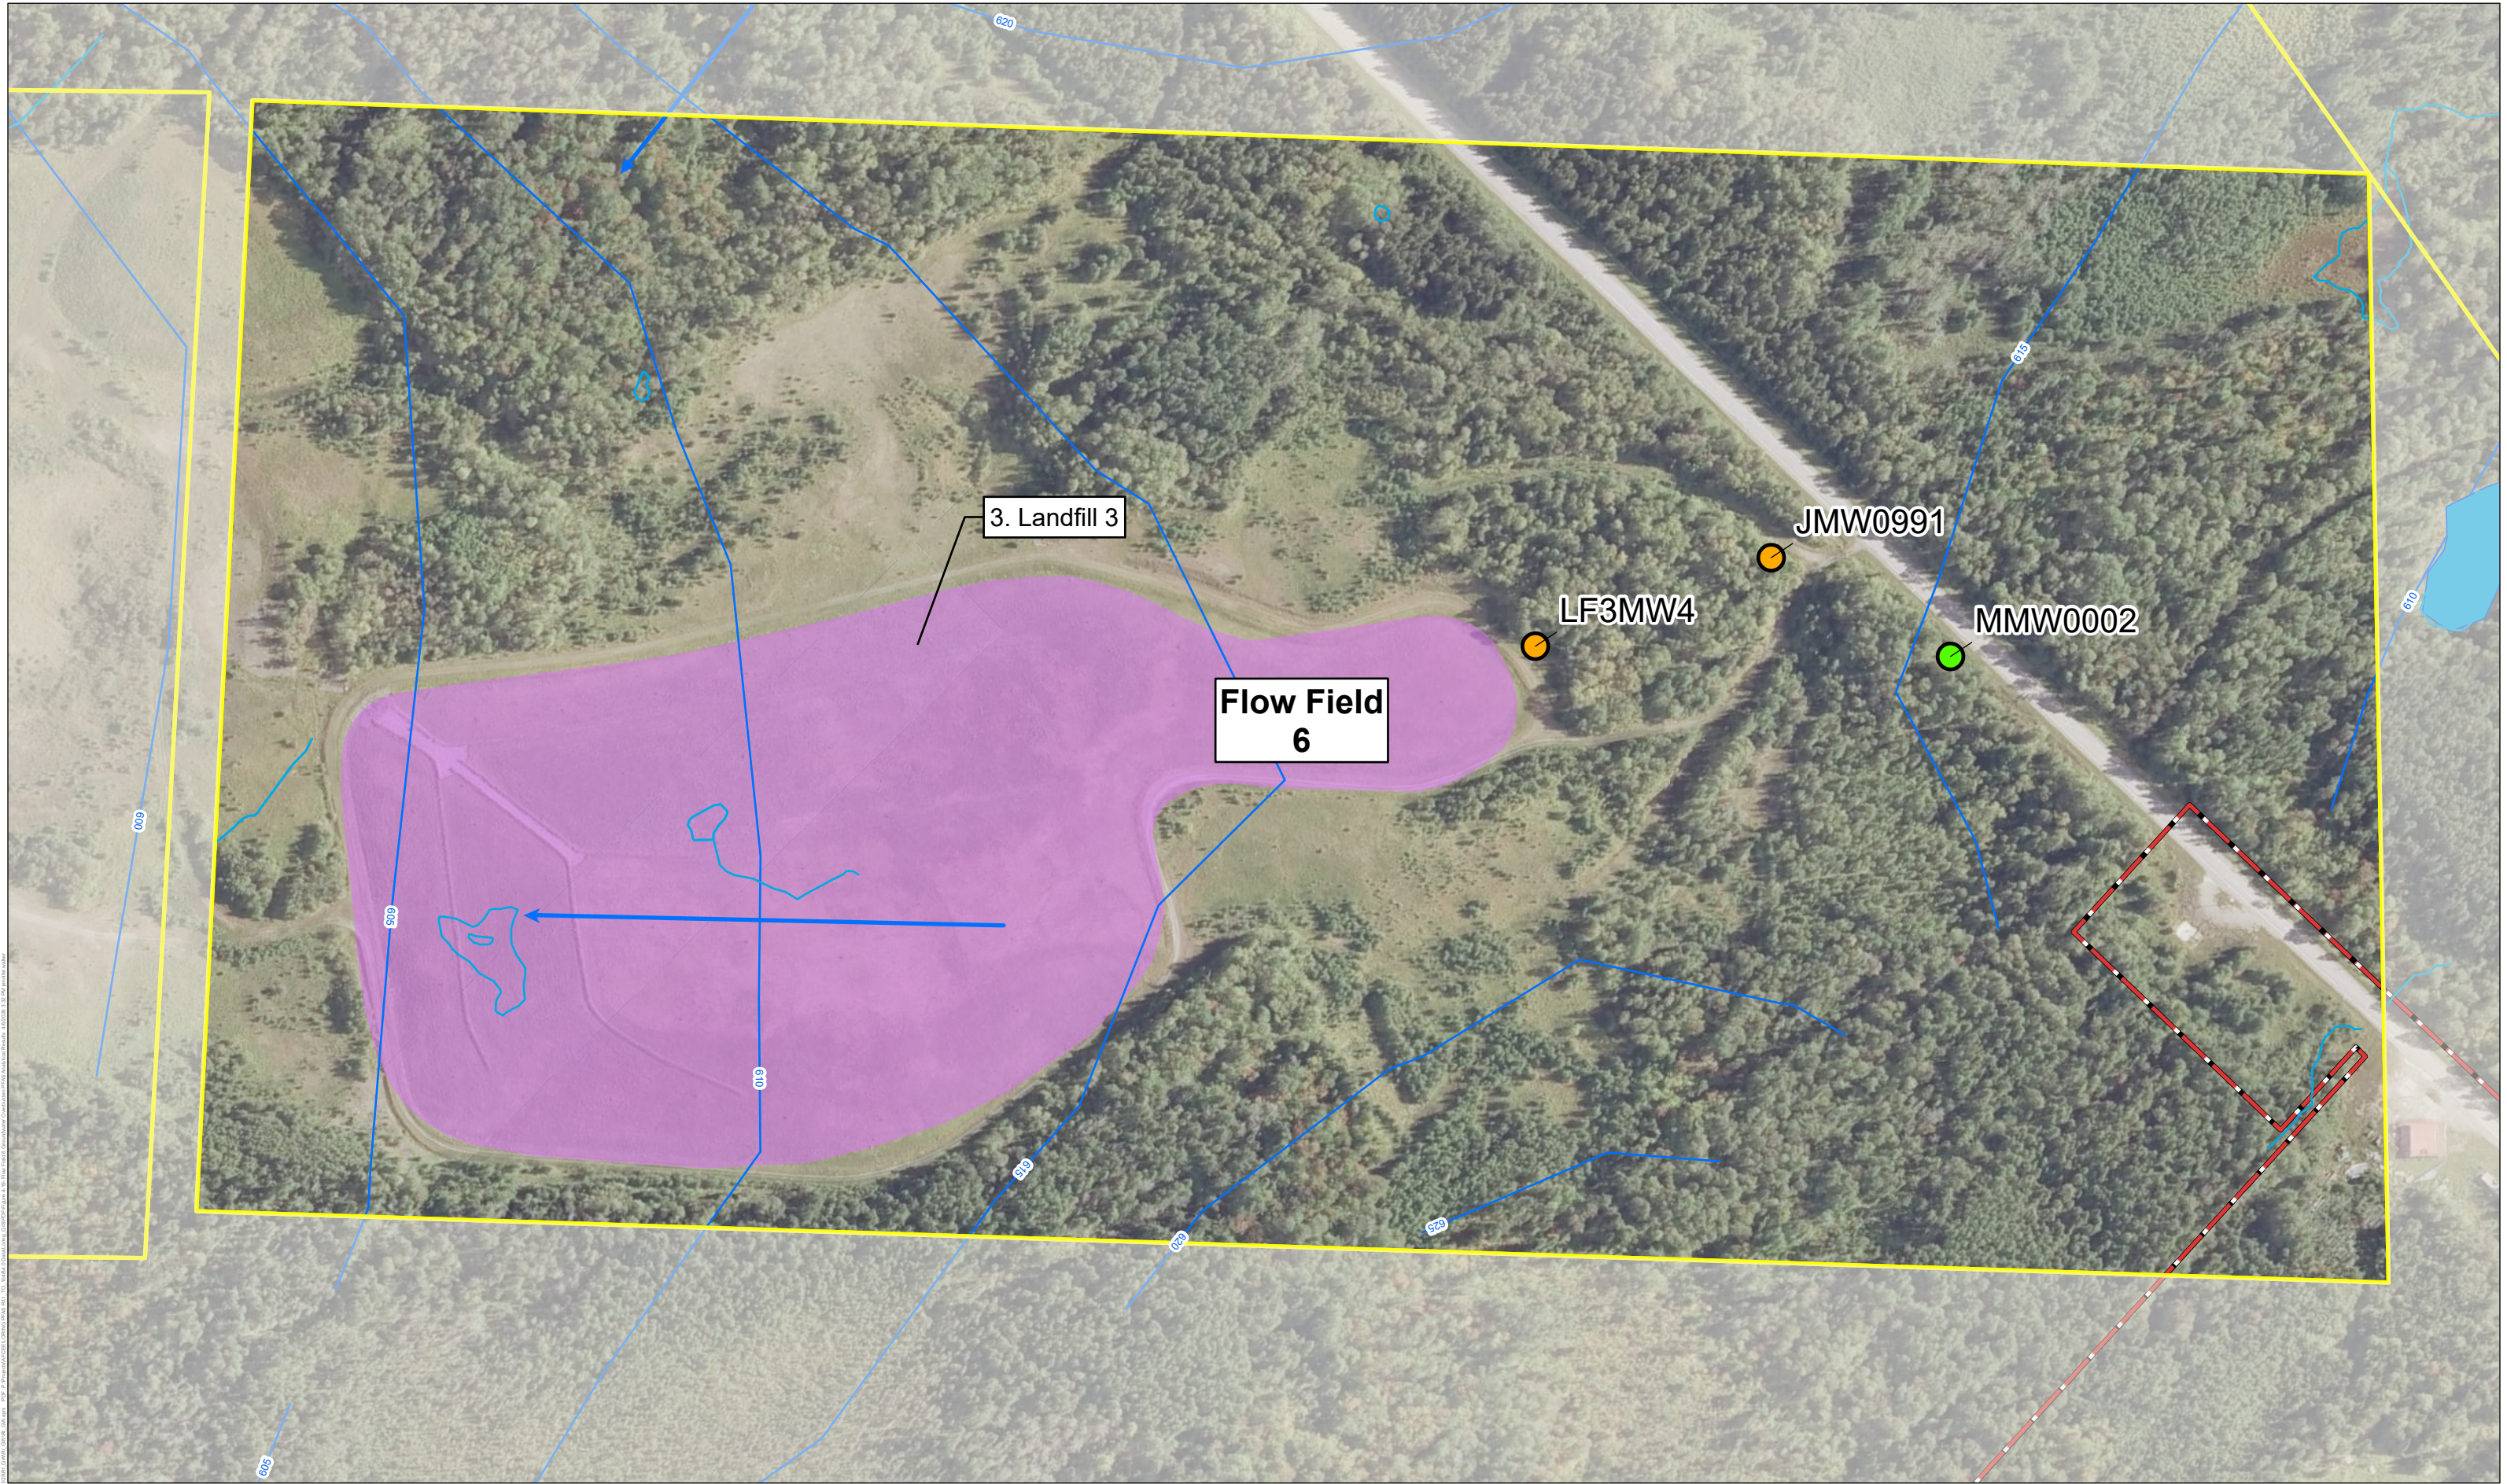
Figure depicts most recent sampling result for each location.
