**Air Force Civil Engineer Center**  
2261 Hughes Ave., Suite 163  
JBSA Lackland, TX 78236

**Figure 4-24C**  
Surface Water, Sediment, Hydric Soil, Shallow Groundwater, and Porewater Analytical Results  
Lower West Branch and East Branch of Greenlaw Brook Drainage Basin  
Remedial Investigation Site Characterization Summary Report  
Former Loring Air Force Base, Limestone, ME

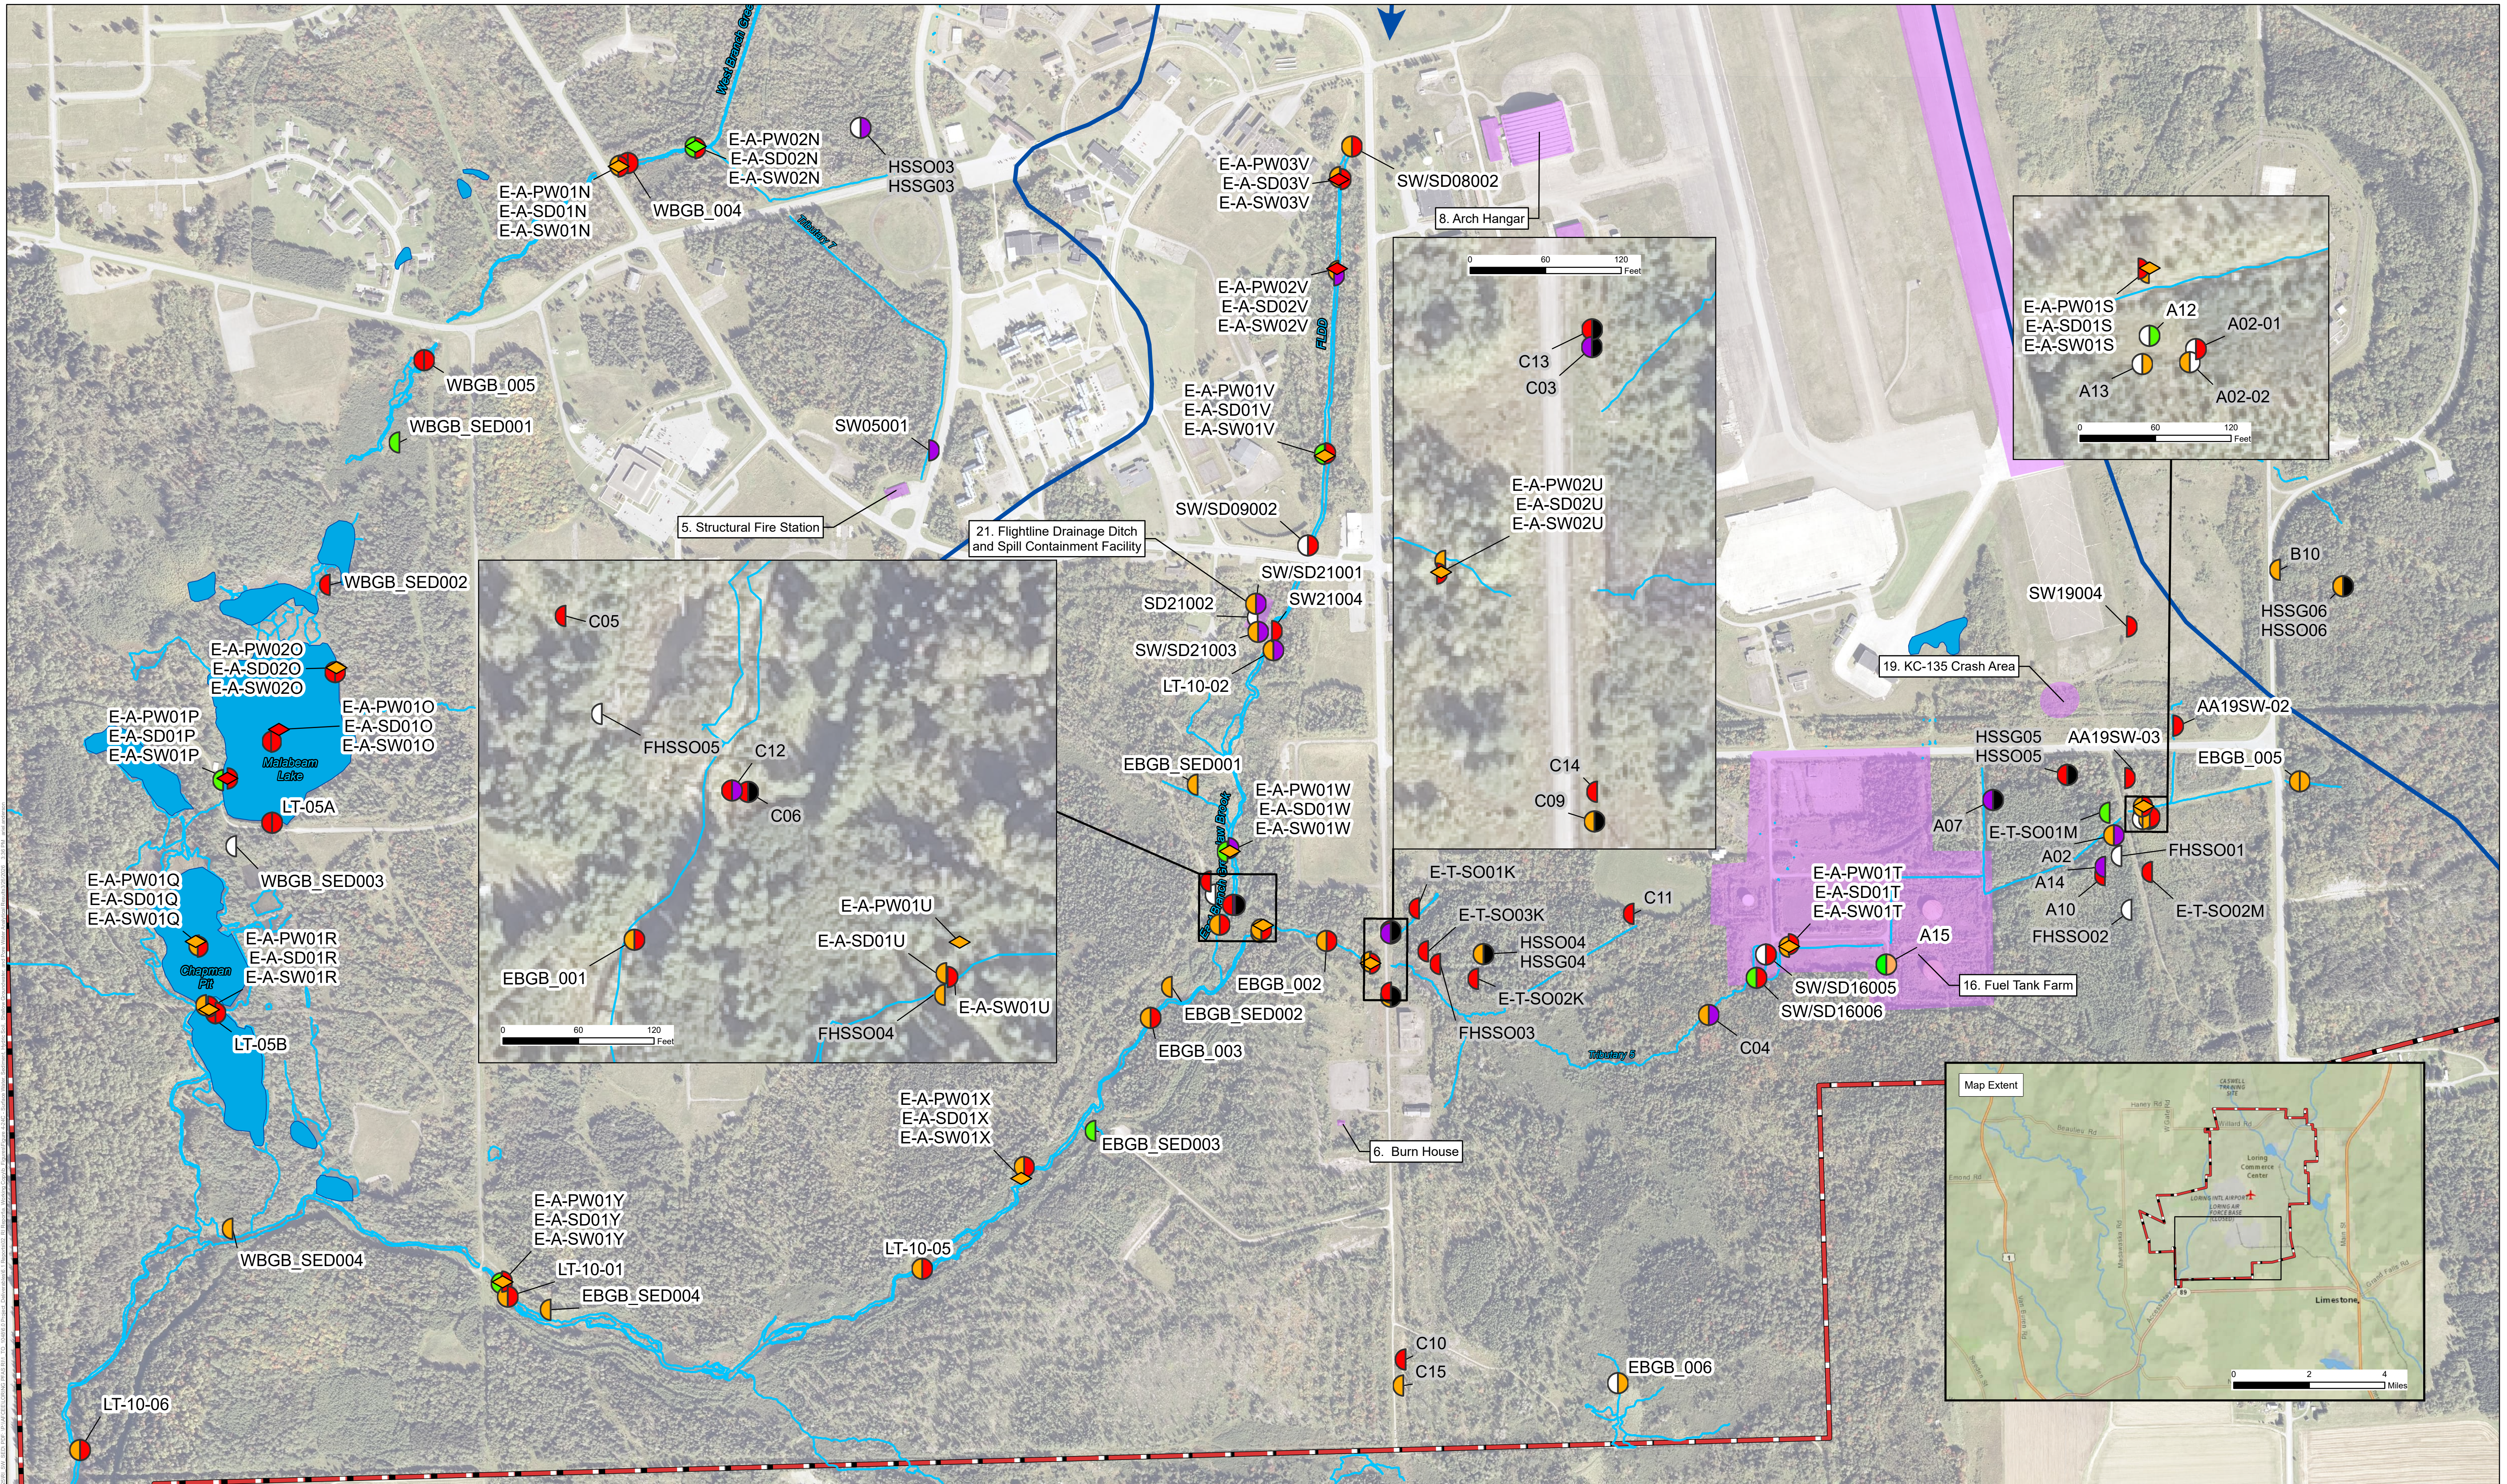
**Notes:**  
Depicted concentrations represent the greatest exceedance of a regulatory value for the PFAS compounds with an applicable health based screening level or ecological risk assessment benchmark.  
See Table 1-3 for more information about screening levels.
