**Figure 3-1**  
**Flow Fields and Investigated Source Areas**  
Remedial Investigation Site Characterization Summary Report  
Former Loring Air Force Base, Limestone, ME

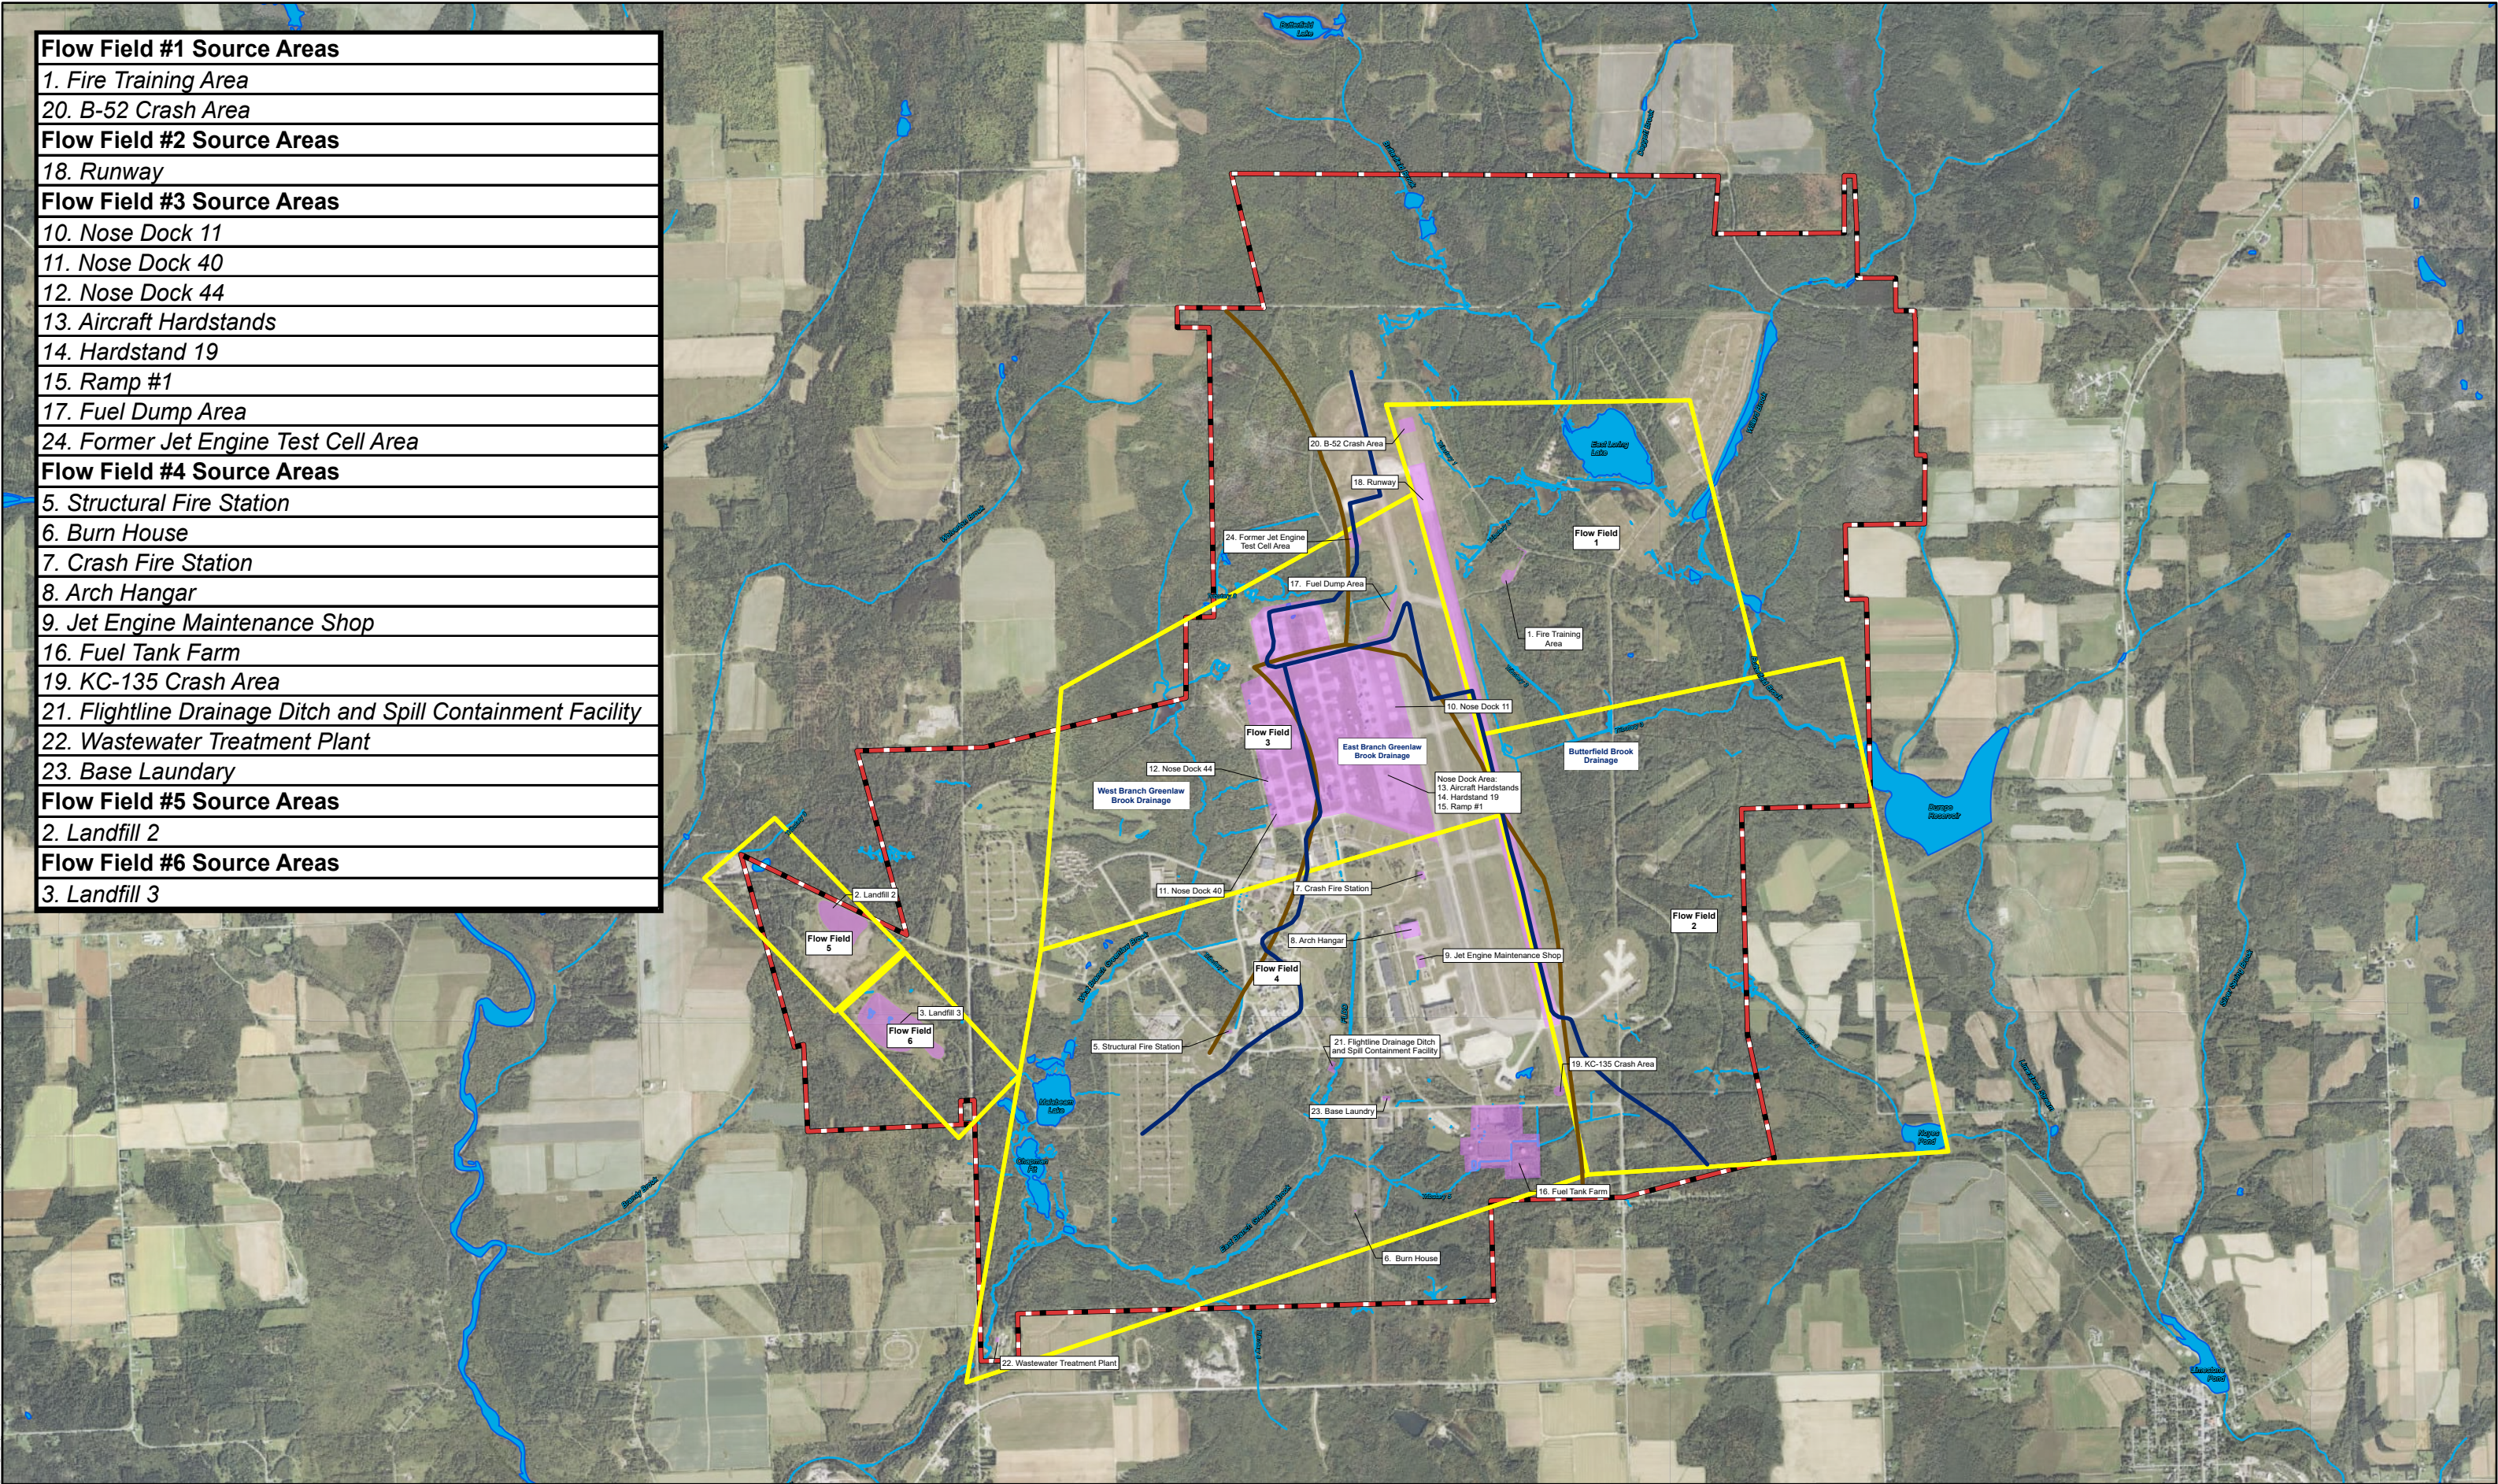
| <b>Flow Field #1 Source Areas</b> |
| <b>Flow Field #2 Source Areas</b> |
| <b>Flow Field #3 Source Areas</b> |
| <b>Flow Field #4 Source Areas</b> |
| <b>Flow Field #5 Source Areas</b> |
| <b>Flow Field #6 Source Areas</b> |
