**Air Force Civil Engineer Center**  
2261 Hughes Ave., Suite 163  
JBSA Lackland, TX 78236

**Figure 4-12**  
**Flow Field 2 Bedrock Groundwater Composite PFAS Analytical Results**  
Remedial Investigation Site Characterization Summary Report  
Former Loring Air Force Base, Limestone, ME

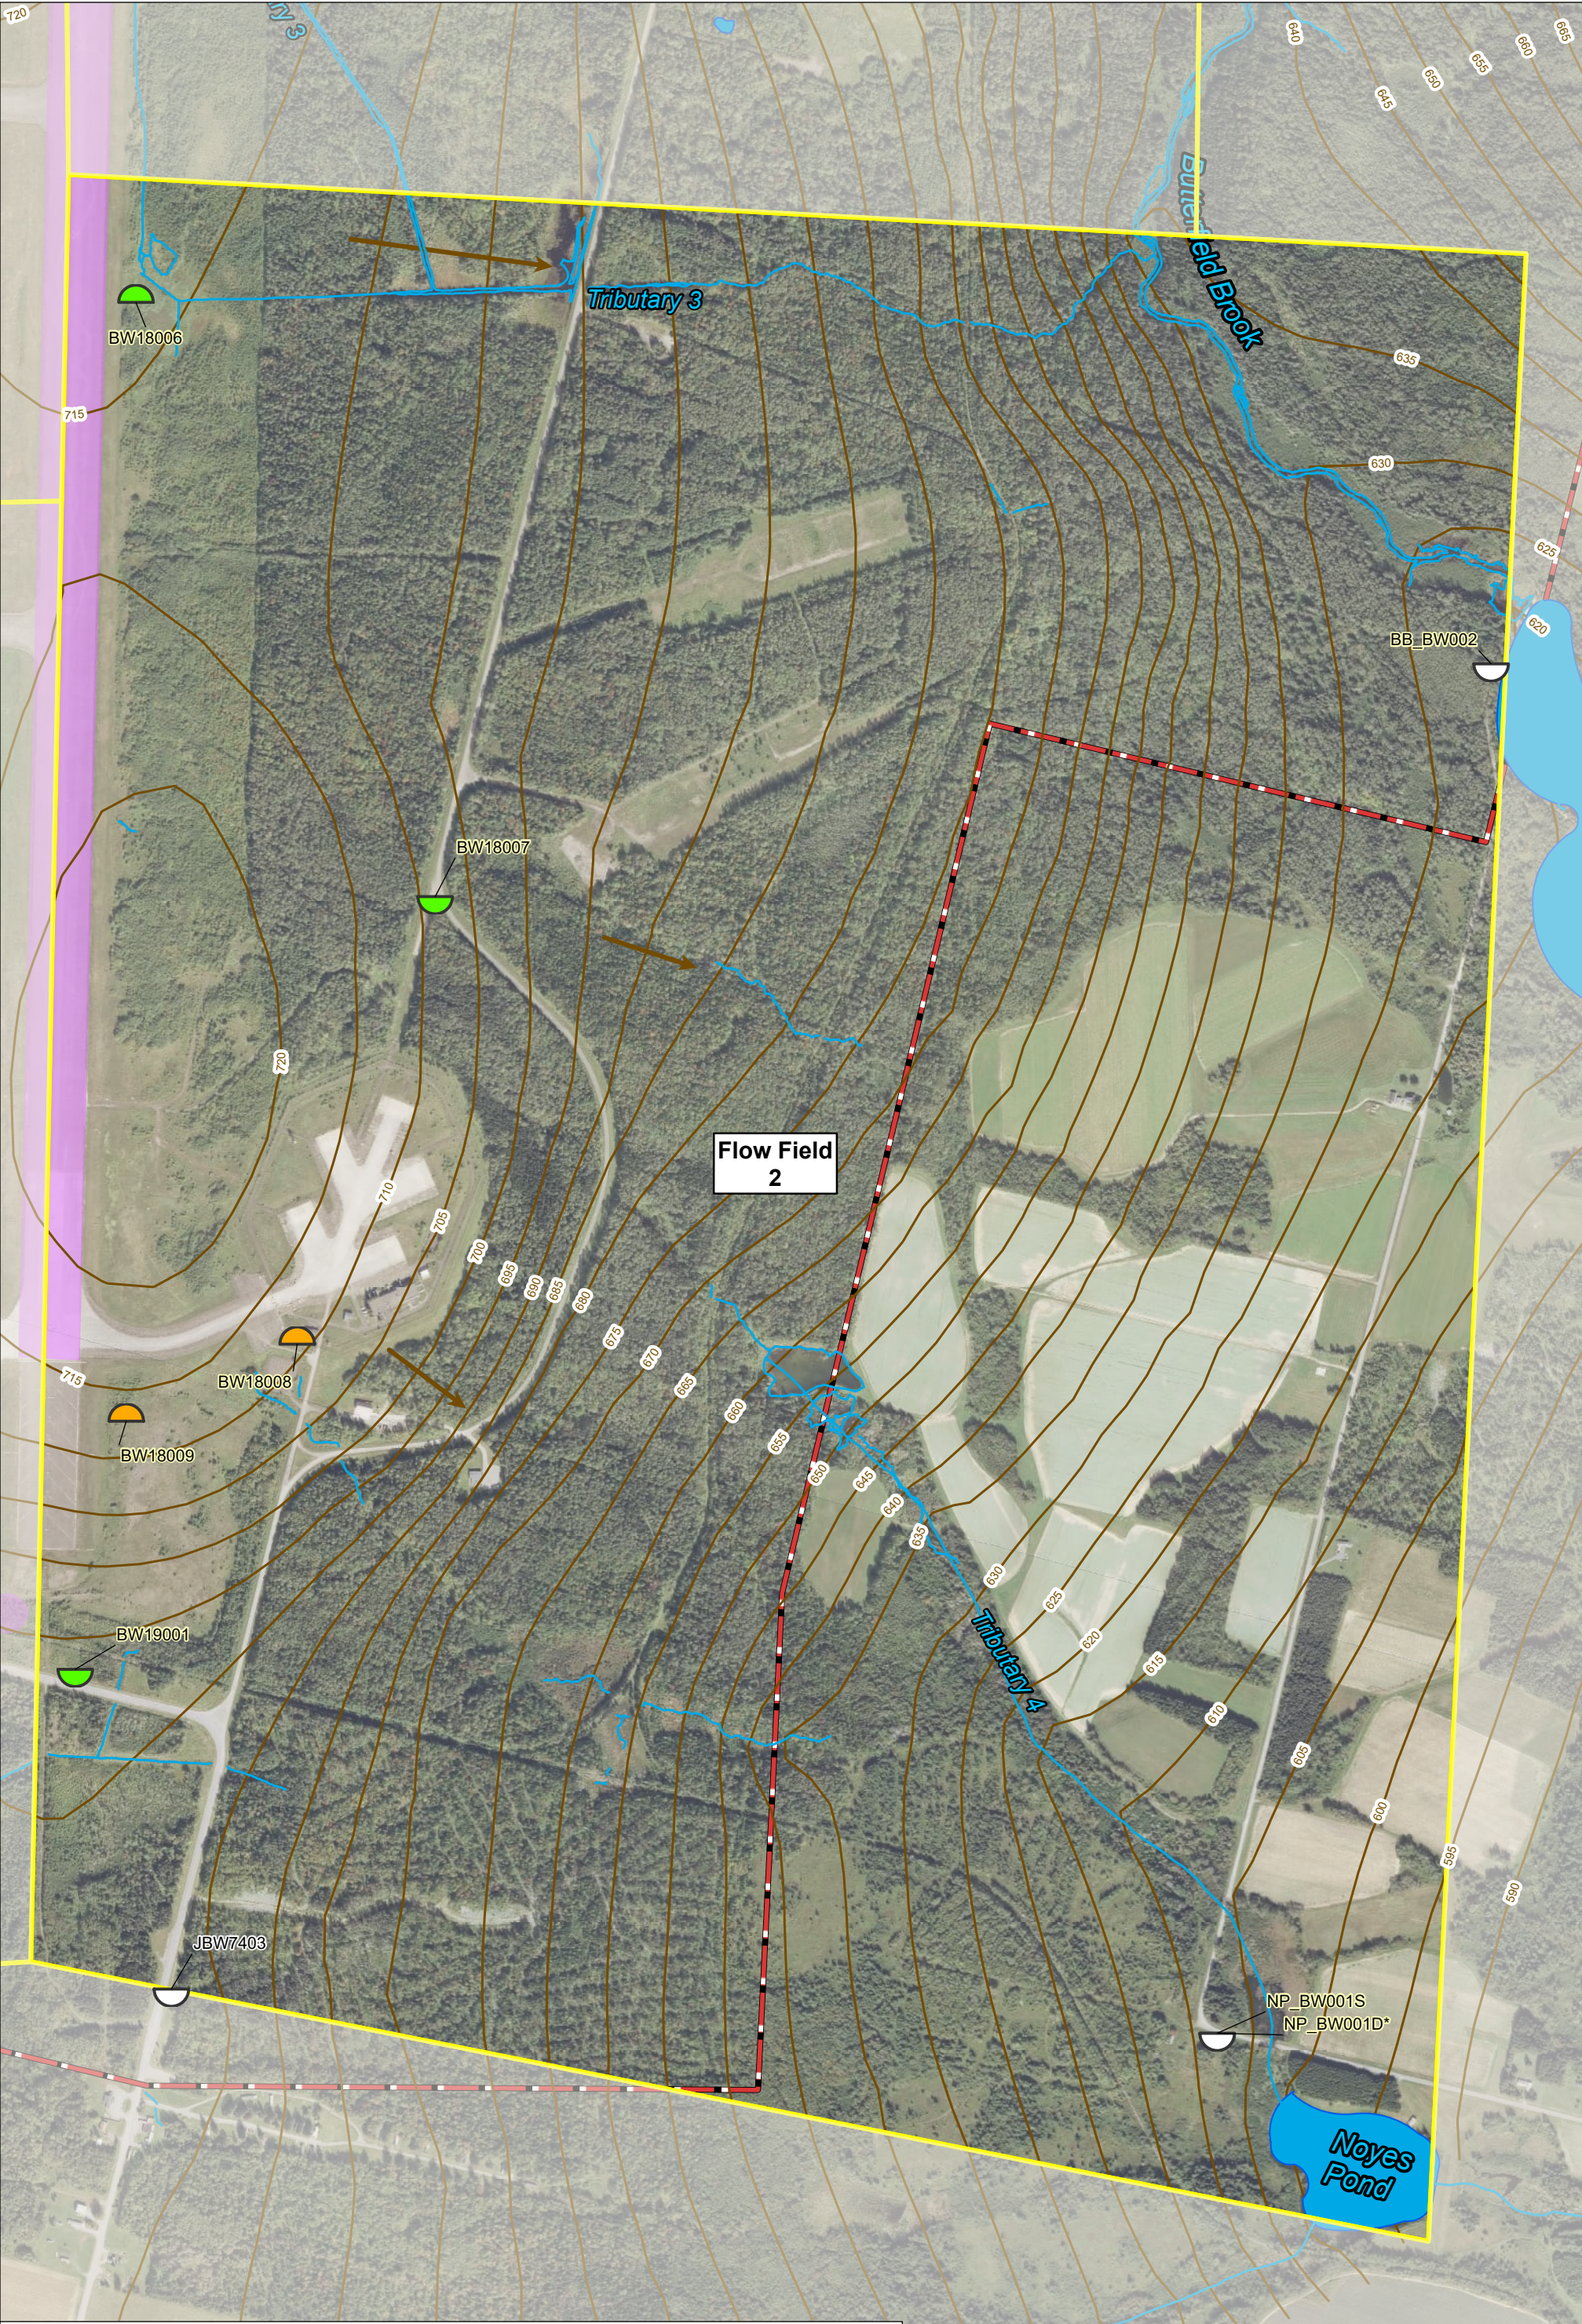
Figure depicts most recent sampling result for each location.  
\*\*See Table 1-3 for more information about screening levels
